# Quimby Lane Preliminary Investigation

Topology

Bernardsville  
Planning Board

**December 12, 2019**

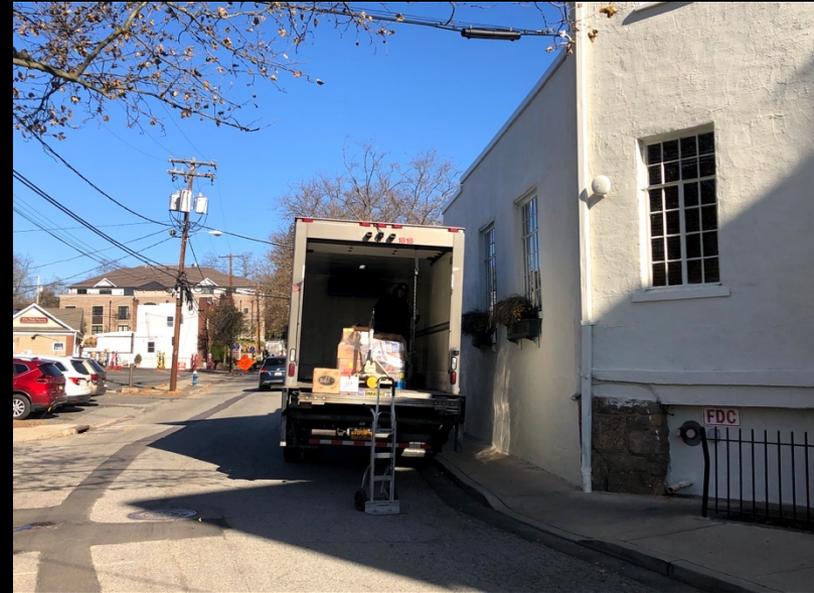
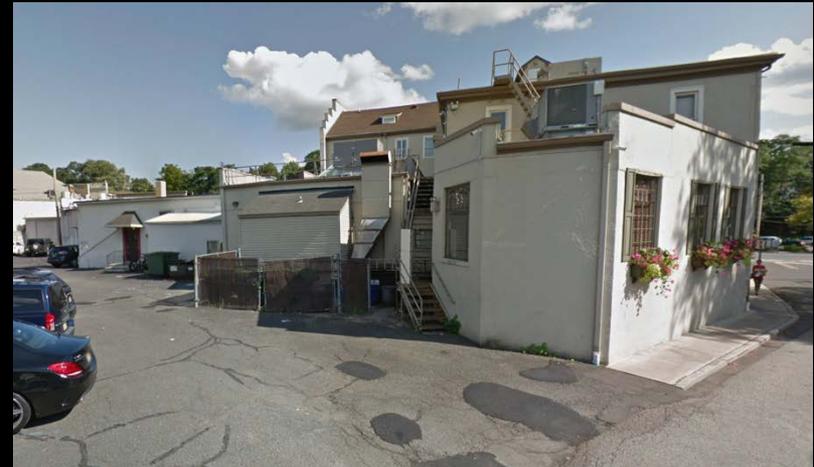
# Block 70, Lot 1: Criterion D

- Faulty arrangement, obsolete layout, and excessive land coverage are detrimental to health, safety, and welfare
  - Retrofit of site to accommodate more intensive uses and auto-oriented environment
  - Loading on Quimby impedes flow of traffic and creates safety hazard by impeding visibility. No dedicated loading area for trash.
  - Rear staircase exits into driveway via blind turn
  - Lack of striping to mark circulation patterns
  - Excessive land coverage exacerbates flooding and detracts from pedestrian environment, particularly relevant in the Special Flood Hazard Area

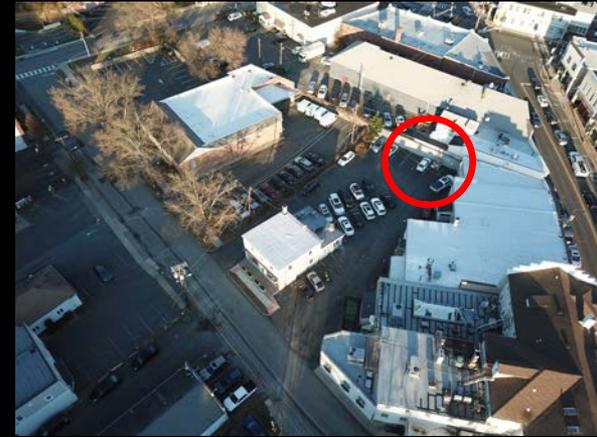
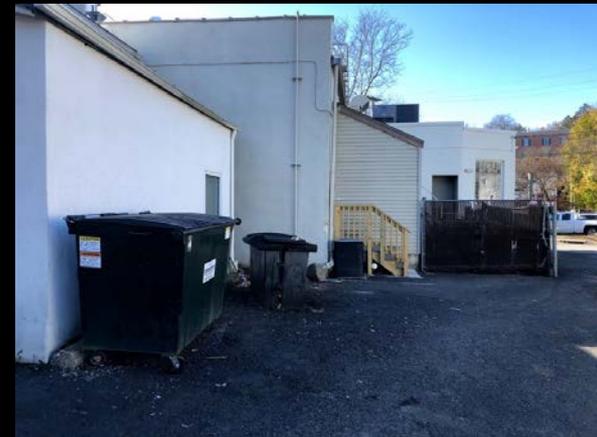
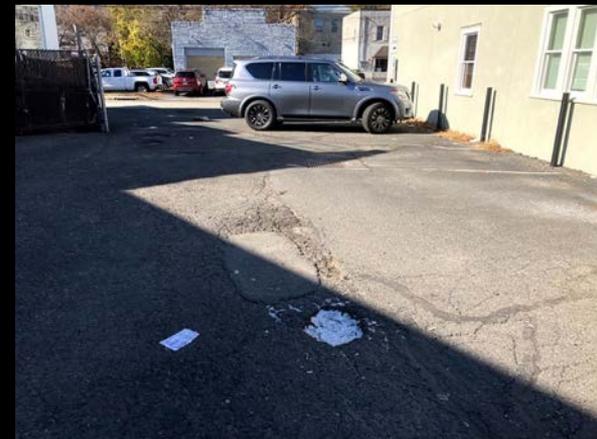
# Block 70, Lot 2: Criterion D

- Excessive land coverage, faulty arrangement of sanitary and waste management facilities, dilapidated improvements detrimental to health, safety, welfare
  - Excessive land coverage exacerbates flooding and detracts from pedestrian environment, particularly relevant in the Special Flood Hazard Area
  - Dumpsters lacking screening detract from aesthetic quality, can attract vermin, and cause waste to spread
  - Dumpster located in a parking space for a lengthy period of time reflective of faulty arrangement
  - Cracked and dilapidated improvements

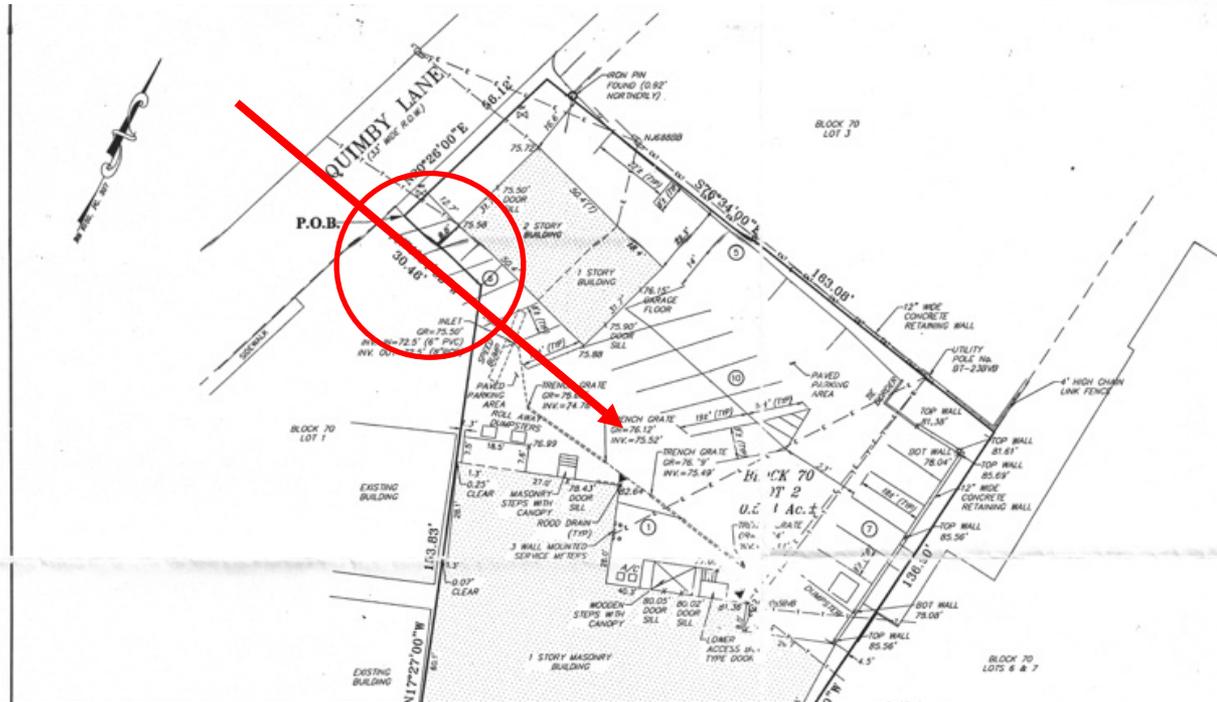
# Block 70, Lot 2: Criterion E

- Functionality of property and Lot 1 dependent on cross easement
- Entanglement of title and condition of diverse ownership which may impede future transfer of, and investment, in the property
- Prevents reconfiguration of property in any way that would conflict with, or result in abuse of the easement
- Condition conducive to stagnation and presumed to have negative economic impact

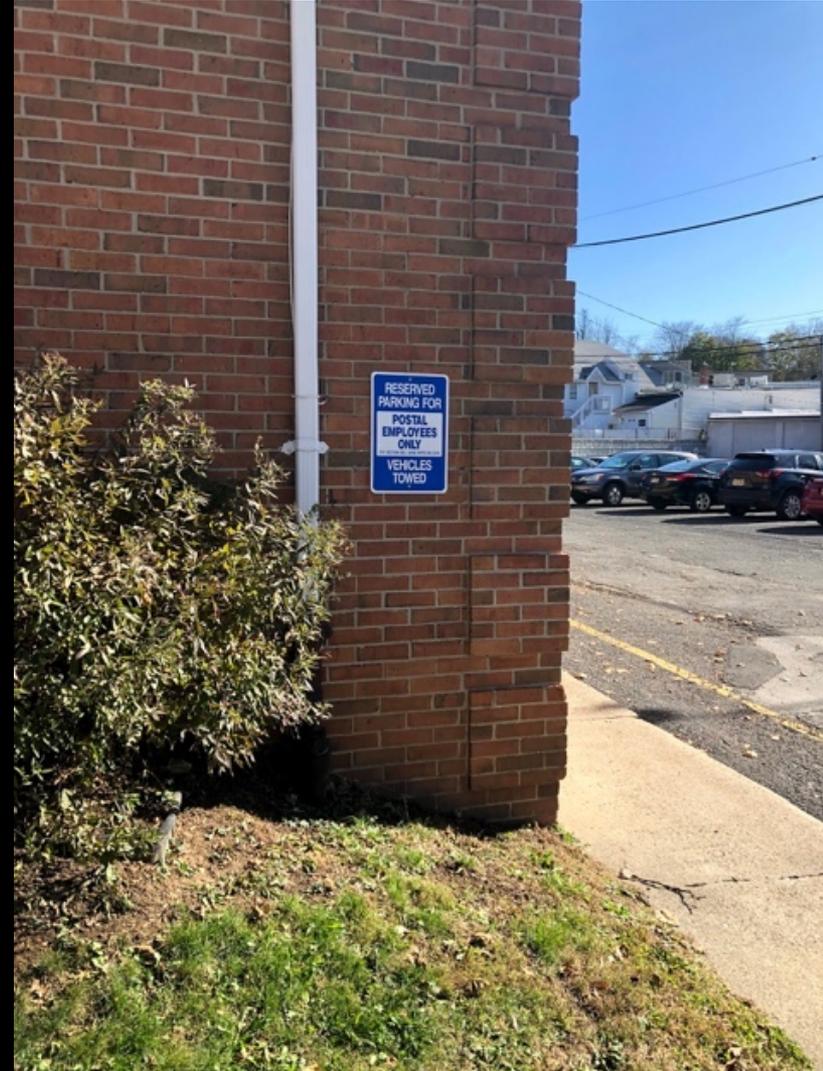
# Block 70, Lot 3: Criterion D

- **Faulty arrangement detrimental to welfare**
  - Based on size of building (6,694 SF) roughly 21 parking spaces should be provided at a conservative ratio of 3 spaces to 1000 SF
  - Physically sufficient parking exists on-site (23 spaces)
  - However, the management of parking area restricts access to employees and tenant trucks. (i.e. “other factors”)
  - No customer parking provided on-site.
  - Adjacent property used for customer parking is public parking, but not provided pursuant to lease or easement.

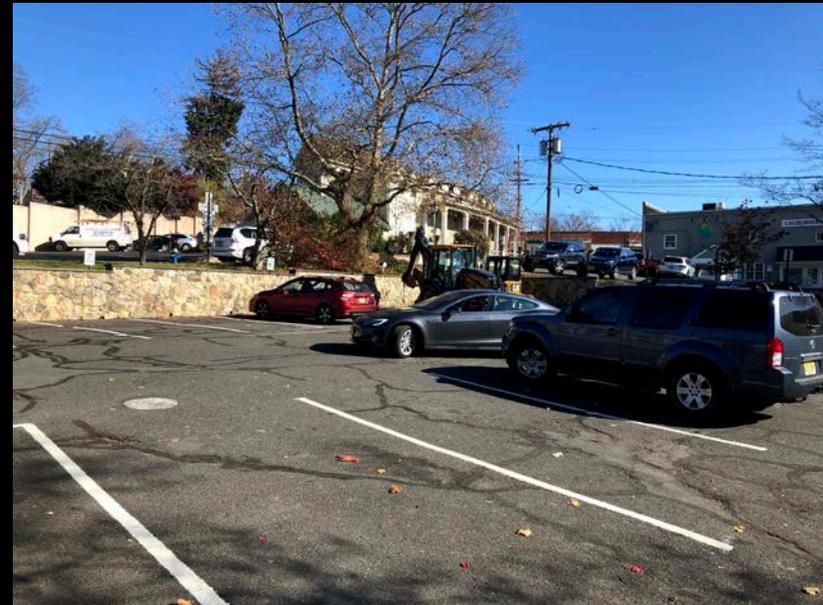
# Block 70, Lot 4: Criterion D

- **Obsolete land use detrimental to welfare**
  - Concerned Citizens supported finding that surface parking lots in downtown areas are evidence of obsolescence
  - Borough has undertaken effort to move away from auto-oriented uses and surface parking lots of “yesterday” in the downtown as reflected in 2004 Master Plan
  - Surface parking lots detract from pedestrian environment and discourage walkability, exhibit excessive lot coverage ratios that exacerbate flooding, and do not generate significant tax revenue
    - Improvement value of Block 70, Lot 4 per acre is \$0
    - Borough wide average is \$174,133

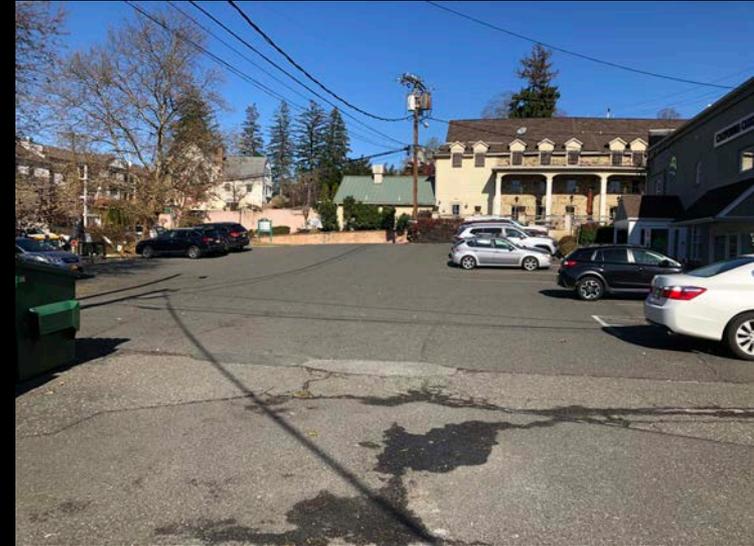
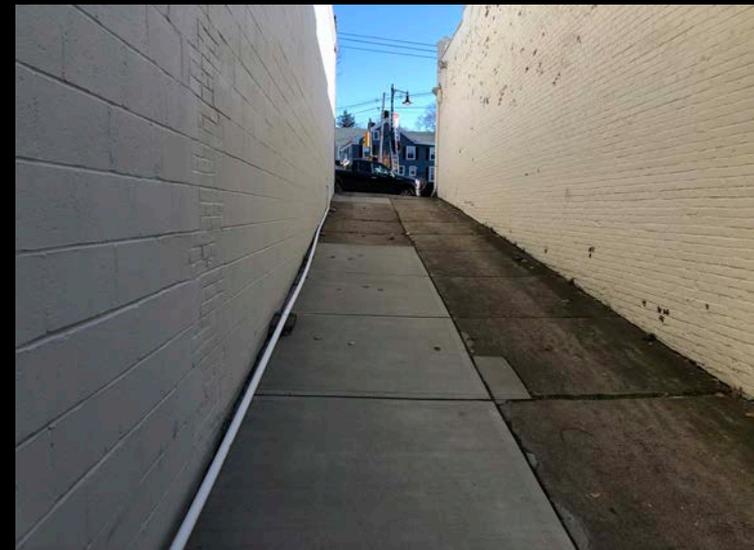
# Block 70, Lot 6, 6.01-6.08: Criterion D

- **Faulty arrangement and excessive land coverage detrimental to safety welfare**
  - Roughly 13,100 SF of commercial space serviced via 17 parking spaces (less than half of required under zoning)
  - Lack of parking detrimental to welfare by limiting viability of businesses and potential expansion
  - Only on-site vehicular access provided via extremely narrow driveway along Olcott Sq. that traverses sidewalk with dangerous conditions and cannot accommodate commercial loading/deliveries
  - Excessive land coverage (flooding / aesthetics)

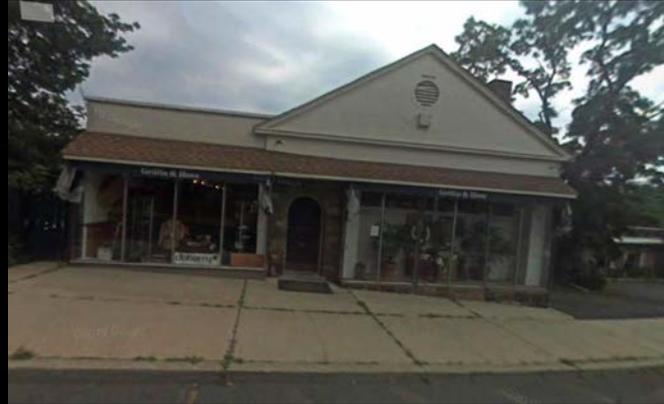
- Building previously used for commercial purposes with significant vacancies for at least two years
  - Primary structure previously used for commercial purposes by Griffin & Howe, a company that manufactures and sells firearms
  - Based on review of imagery, commercial property has been vacant since at least 2016

*July 2009:  
Occupied*

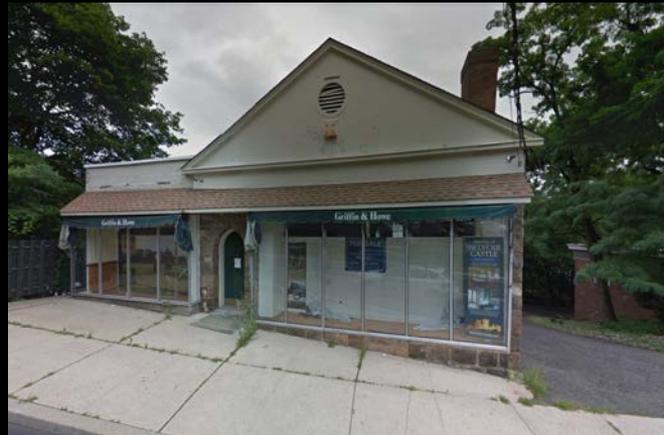
*August 2016:  
Vacant*

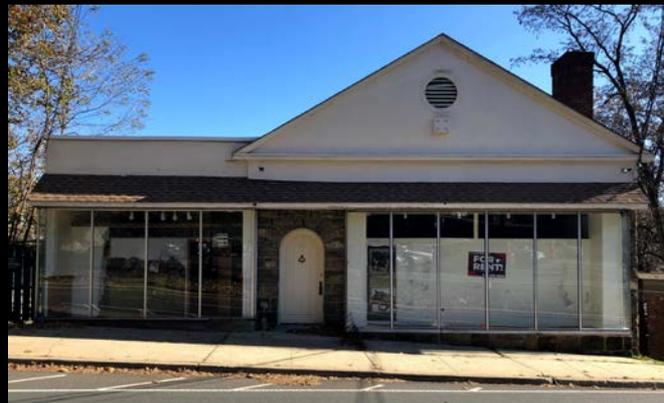
*November 2019:  
Vacant*

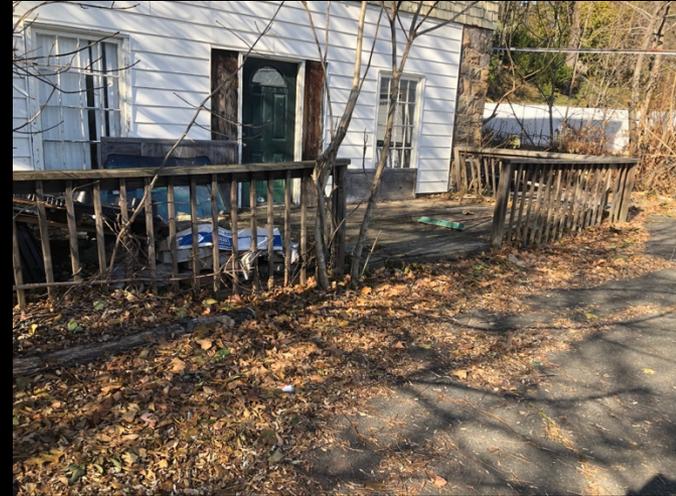
# Block 71, Lot 4: Criterion D

- **Faulty arrangement detrimental to safety and welfare**
  - Property includes improvements on both sides of Mine Brook
  - Improvements are connected via wood bridge
  - Bridges create a “damming” effect by trapping debris that impedes the free flow of the waterway
  - “Debris dam” effect may magnify district flooding by blocking the flow of the waterway beneath the structure with insufficient clearance

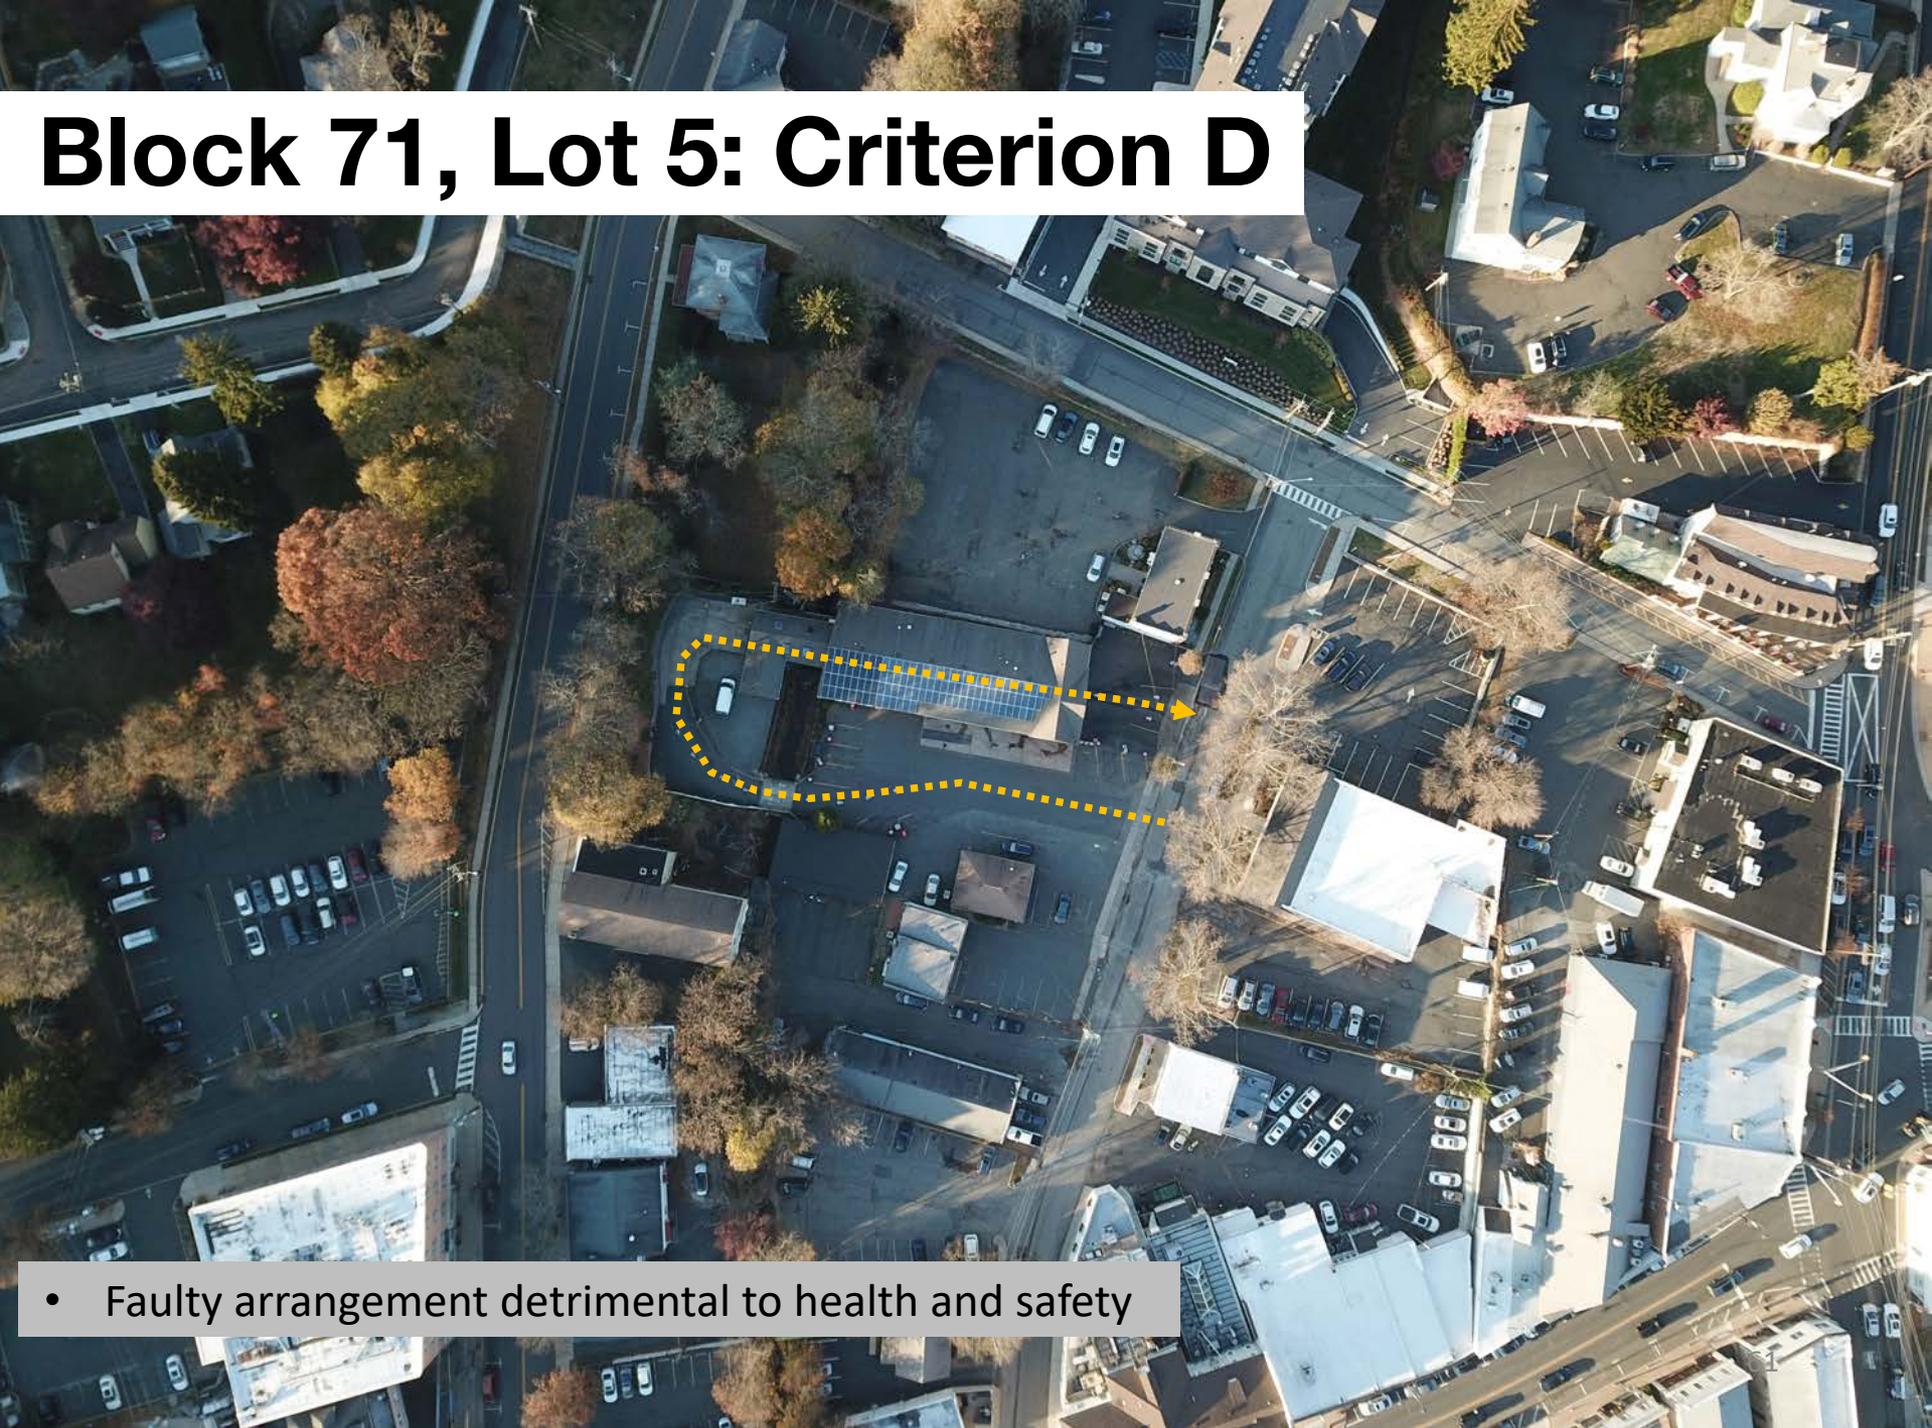
# Block 71, Lot 5: Criterion D

- Faulty arrangement detrimental to health and safety

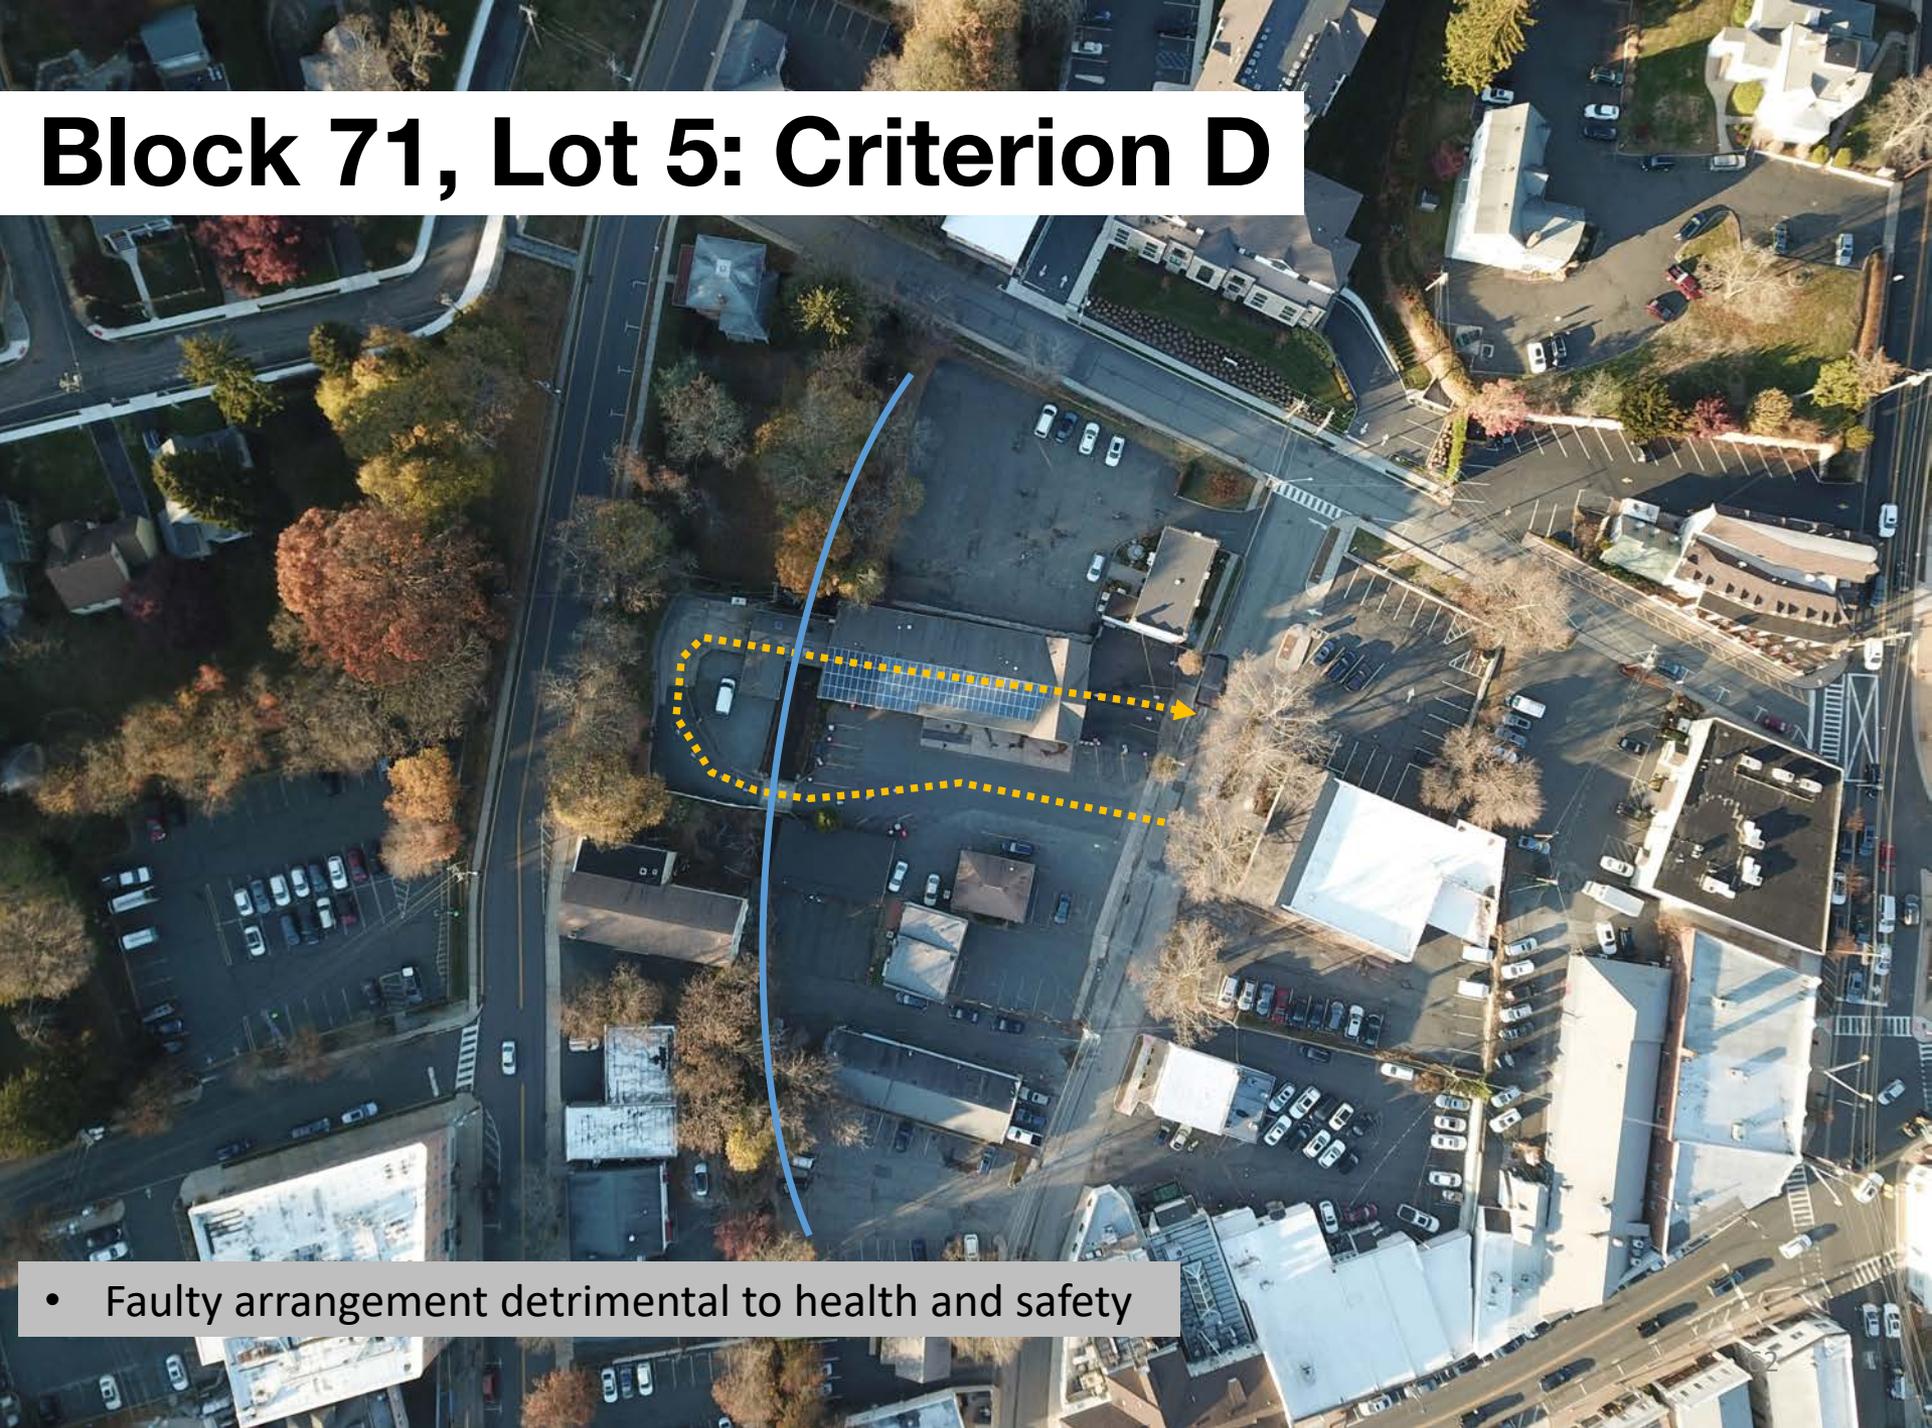
# Block 71, Lot 5: Criterion D

- Faulty arrangement detrimental to health and safety

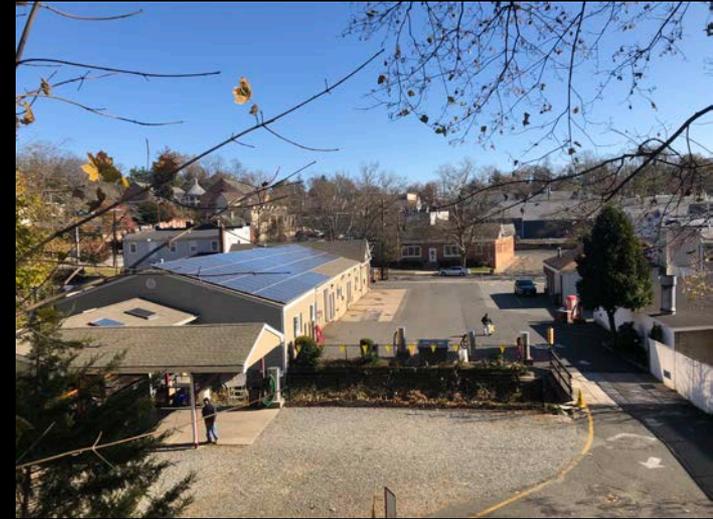
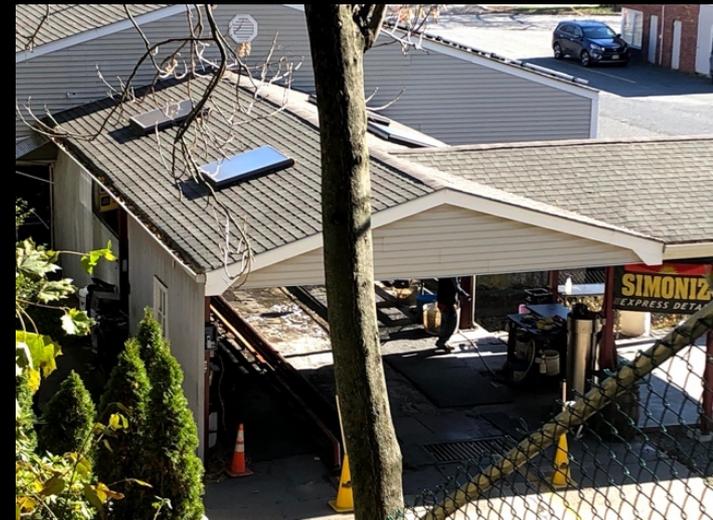
# Block 71, Lot 5: Criterion D

- Faulty arrangement, obsolete layout and use, and excessive land coverage detrimental to health, safety and welfare
  - Circulation pattern requires vehicles to cross Mine Brook and involves car washing activities above the waterway a condition detrimental to health and safety
  - Bridges over Mine Brook create damming effect
  - Development within Regulatory Floodway with excessive land coverage exacerbates flooding and non-point source pollution
  - Excessive curb cuts along Quimby create hazardous condition for pedestrians
  - Obsolete land use that is no longer appropriate for a downtown setting (Concerned Citizens)

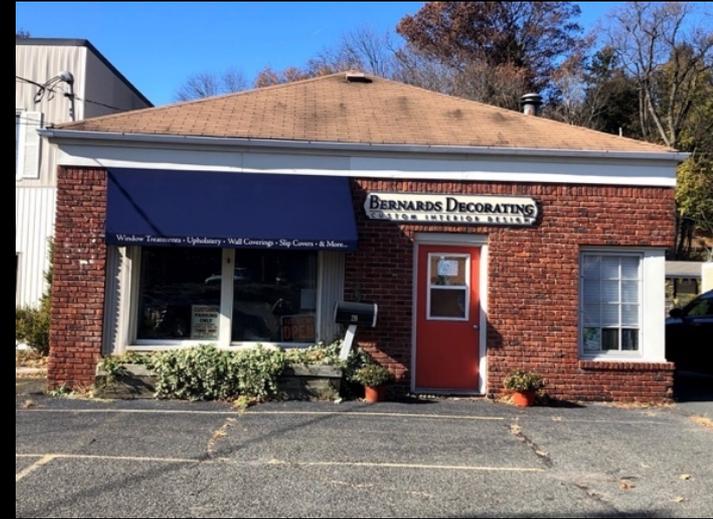
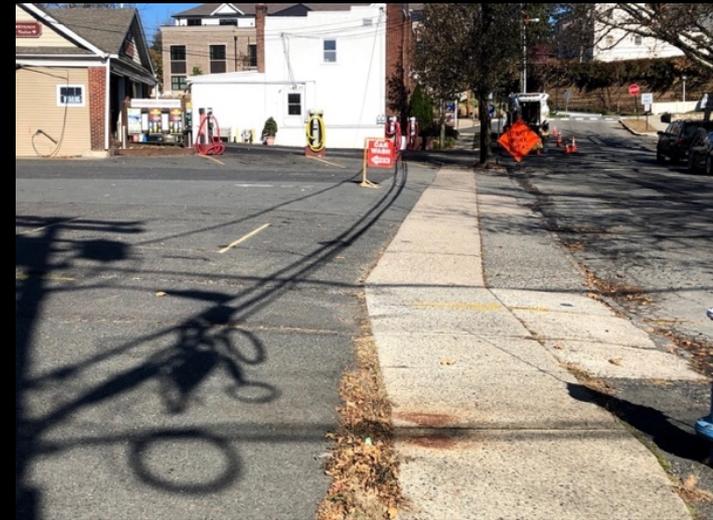
# Block 71, Lot 5.01: Criterion D

- **Faulty arrangement, obsolete layout, and excessive land coverage detrimental to health and safety**
  - Development within Floodway that does not comply with NJDEP standards / best practices results in a faulty arrangement and obsolete layout that is detrimental to health and safety
  - Dilapidated improvements in parking area and sidewalk discourage investment and detract from pedestrian environment
  - Excessive curb cuts create dangerous pedestrian conditions
  - Circulation areas lack striping or wayfinding and are intermingled with adjacent properties creating a hazardous condition (next slide)
  - Front-yard parking reflective of an obsolete layout that detracts from pedestrian environment and economic vibrance

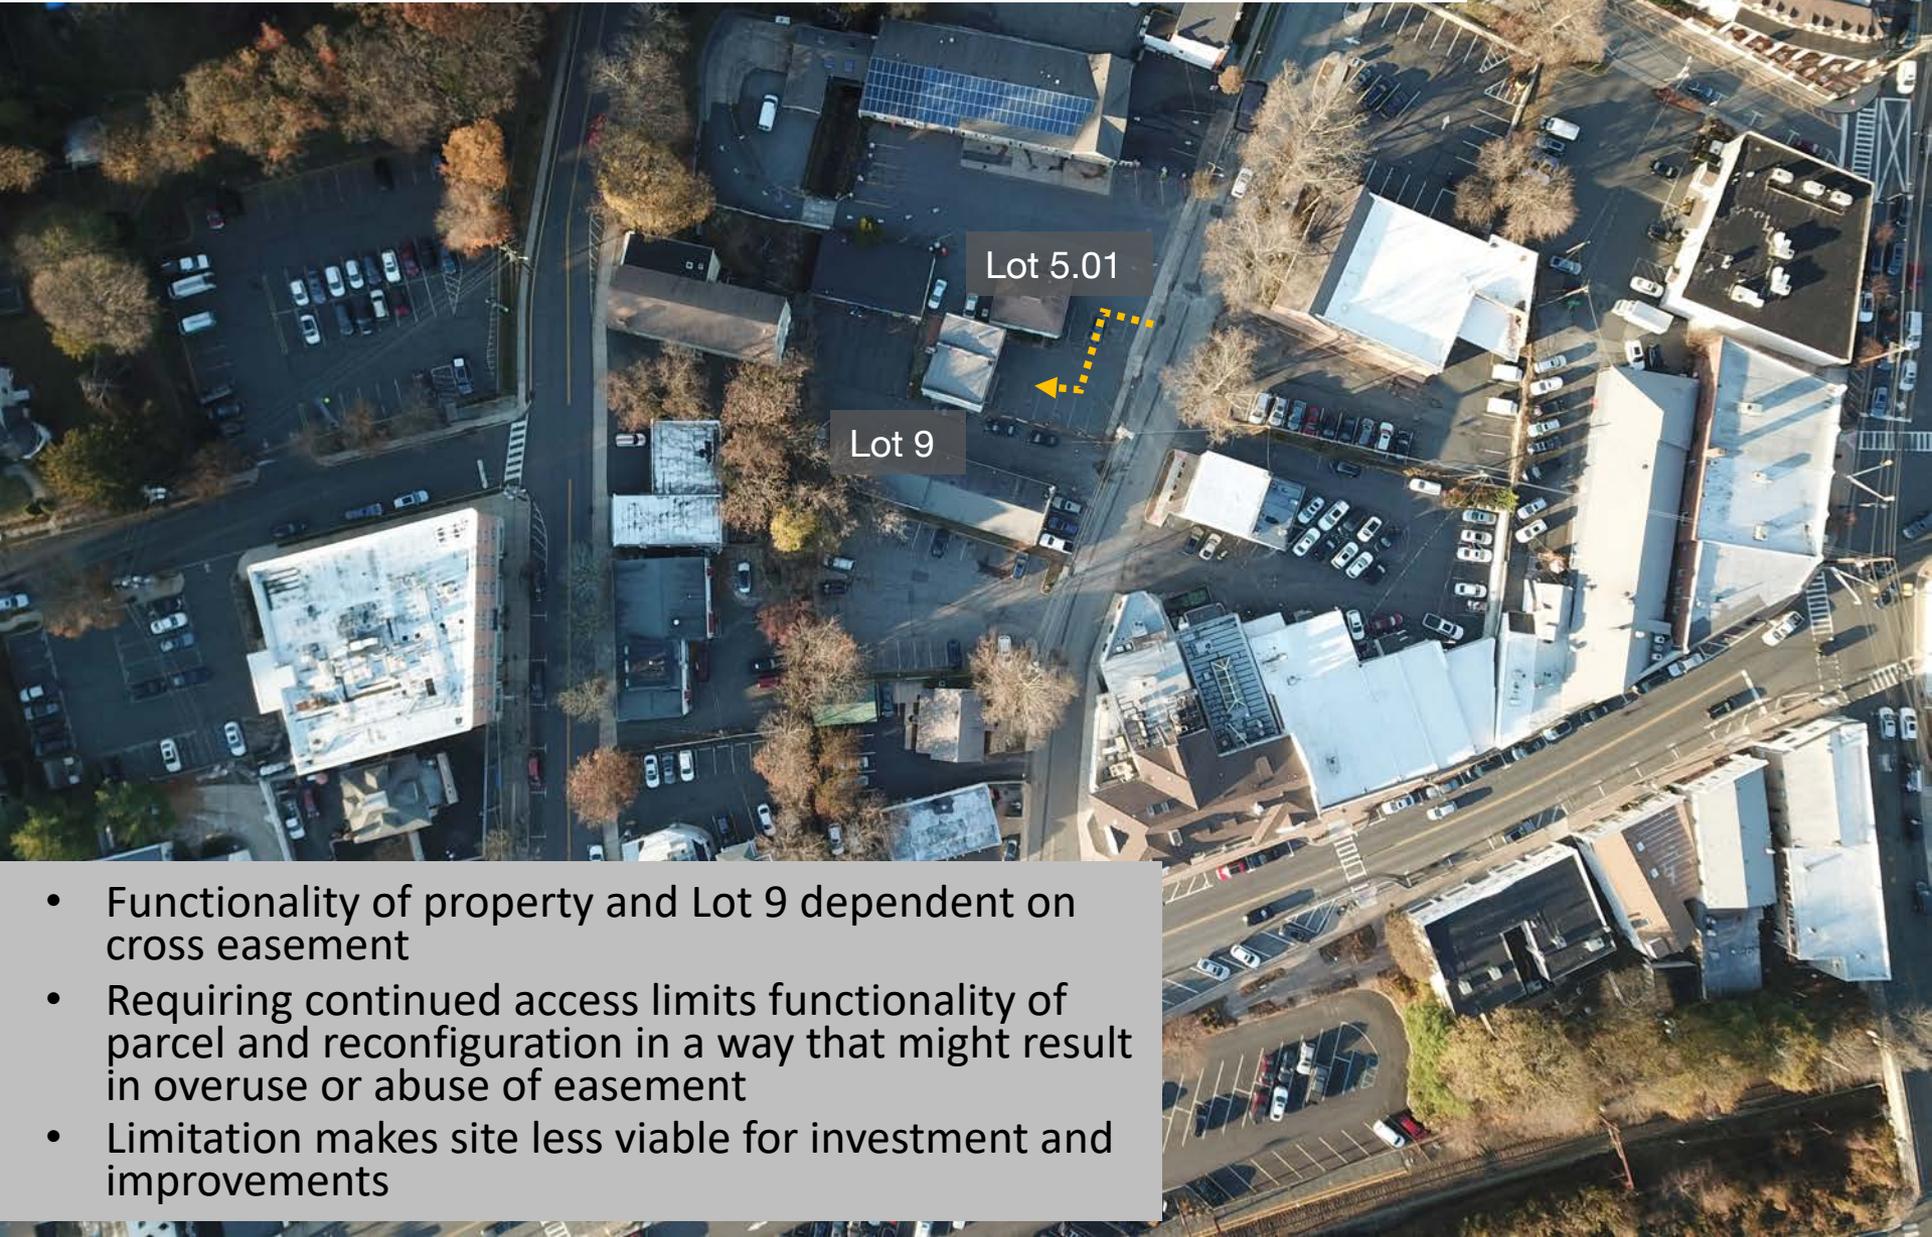
# Block 71, Lot 5.01: Criterion E

- Functionality of property and Lot 9 dependent on cross easement
- Requiring continued access limits functionality of parcel and reconfiguration in a way that might result in overuse or abuse of easement
- Limitation makes site less viable for investment and improvements

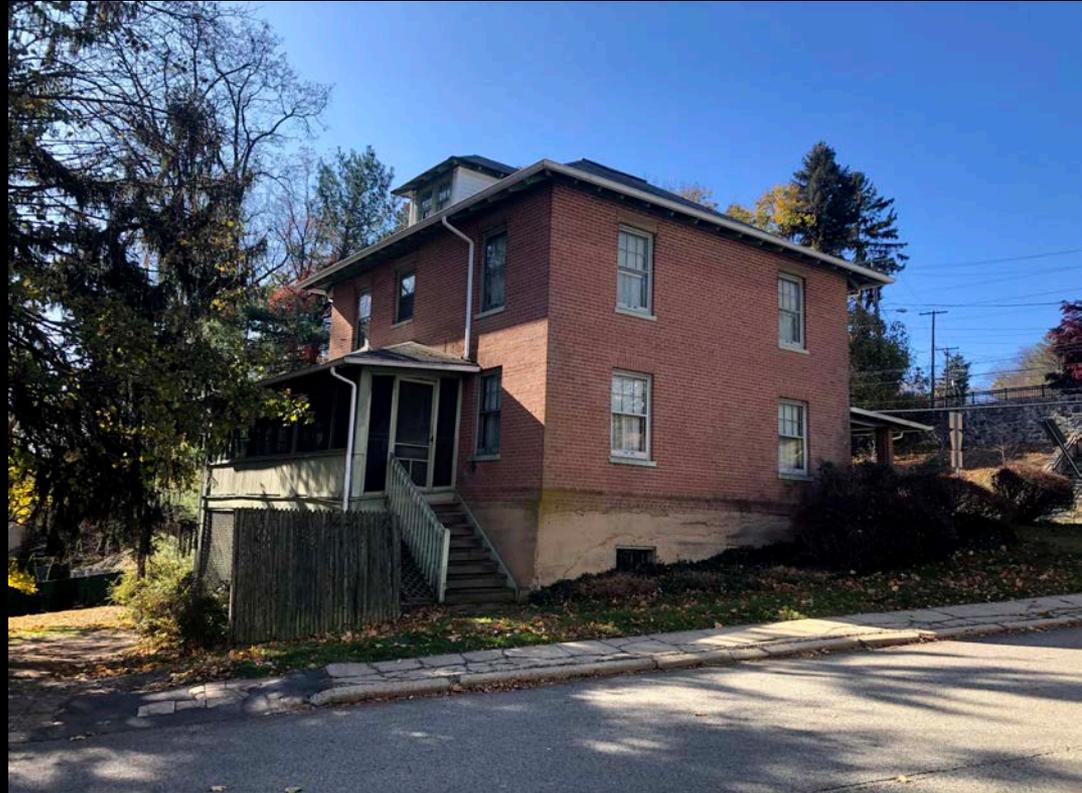
# Block 71, Lot 6: Criterion D

- **Faulty arrangement and obsolete layout detrimental to health and safety**
  - Development within the Regulatory Floodway without corresponding improvements to account for presence of Floodway is detrimental to health and safety both on-site and downstream

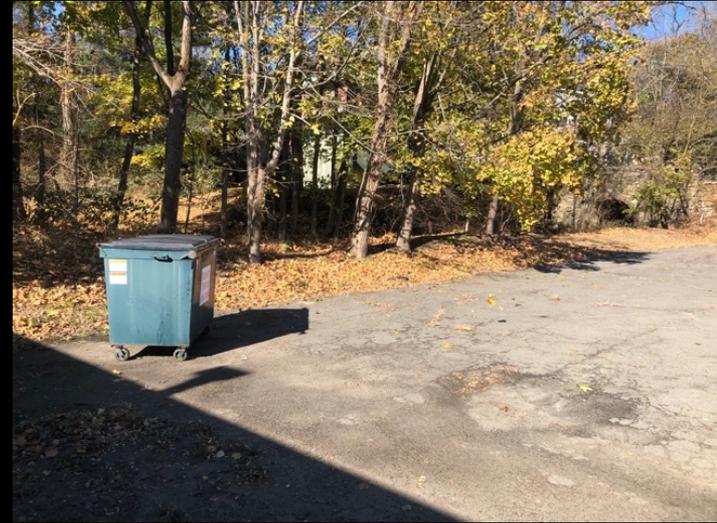
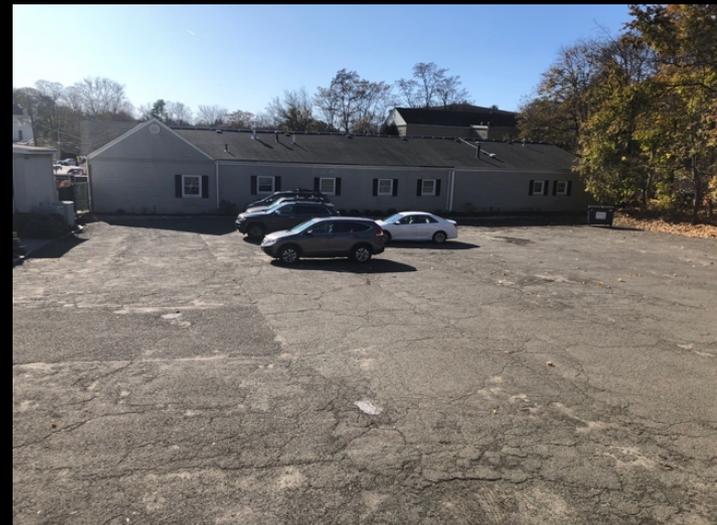
# Block 71, Lots 7, 8: Criterion D

- Faulty arrangement, obsolete layout, and excessive land coverage detrimental to safety and welfare
  - Excessive land coverage within the Floodway reflective of a faulty arrangement detrimental to safety
  - Lack of features to mitigate hazardous Floodway conditions reflective of obsolescence
  - Parking area lacks striping creating a hazardous condition for vehicles and pedestrians
  - Improvements within parking area are cracked and dilapidated
  - Trash area is not delineated or screened reflective of a faulty arrangement

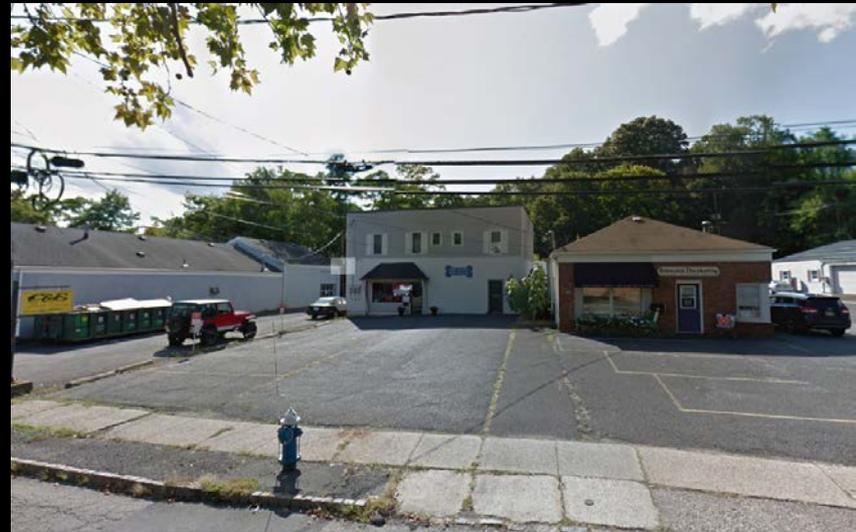
# Block 71, Lot 9: Criterion D

- **Faulty arrangement, obsolete layout, and excessive land coverage detrimental to safety and welfare**
  - Excessive land coverage within the Floodway reflective of a faulty arrangement detrimental to safety
  - Lack of features to mitigate Floodway conditions reflective of obsolescence
  - Lack of striping to indicate circulation patterns for vehicles or pedestrians reflective of faulty arrangement and detrimental to safety
  - Front-yard parking reflective of an obsolete layout that detracts from pedestrian environment and economic vibrance

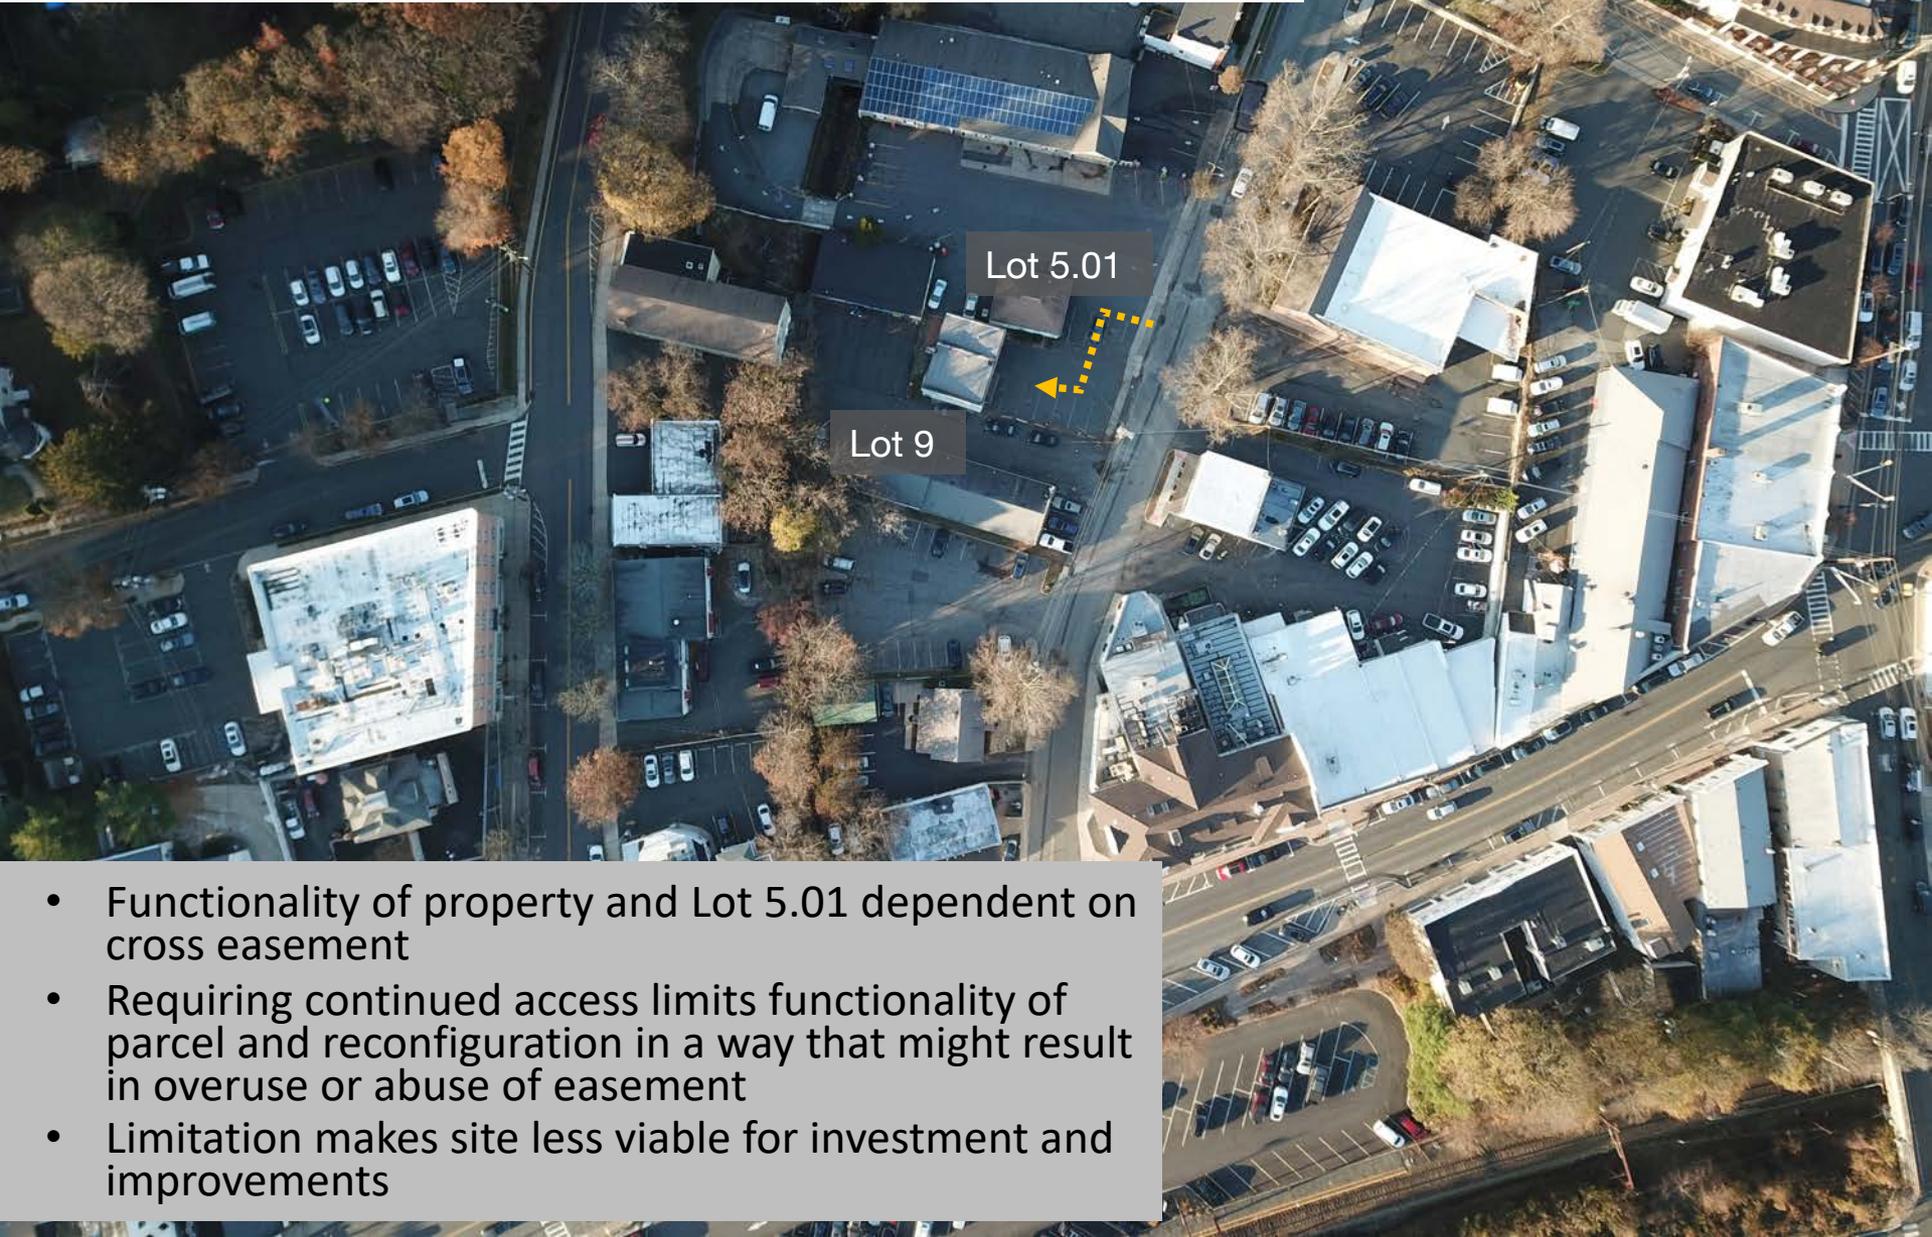
# Block 71, Lot 9: Criterion E

- Functionality of property and Lot 5.01 dependent on cross easement
- Requiring continued access limits functionality of parcel and reconfiguration in a way that might result in overuse or abuse of easement
- Limitation makes site less viable for investment and improvements

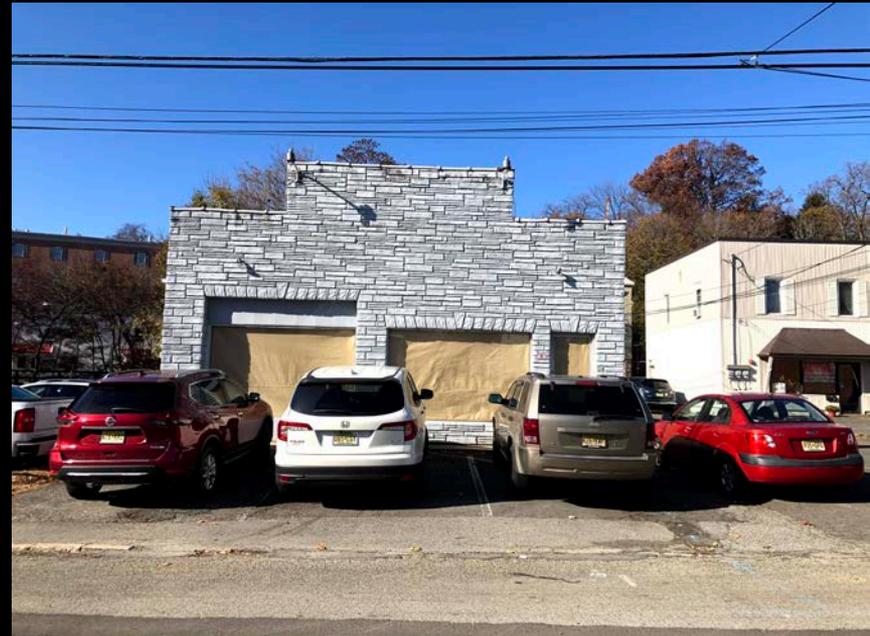
# Block 71, Lot 10: Criterion D

- **Faulty arrangement, obsolete layout, and excessive land coverage detrimental to safety and welfare**
  - Excessive lot coverage within the Floodway reflective of a faulty arrangement detrimental to safety
  - Lack of features to mitigate Floodway conditions reflective of obsolescence
  - Front-yard parking reflective of an obsolete layout that detracts from pedestrian environment and economic vibrance
  - Side setbacks insufficient to permit vehicular access to rear of lot
  - Excessive curb cuts create hazardous pedestrian condition
