# Quimby Lane Preliminary Investigation

Topology

Bernardsville  
Planning Board

**December 12, 2019**

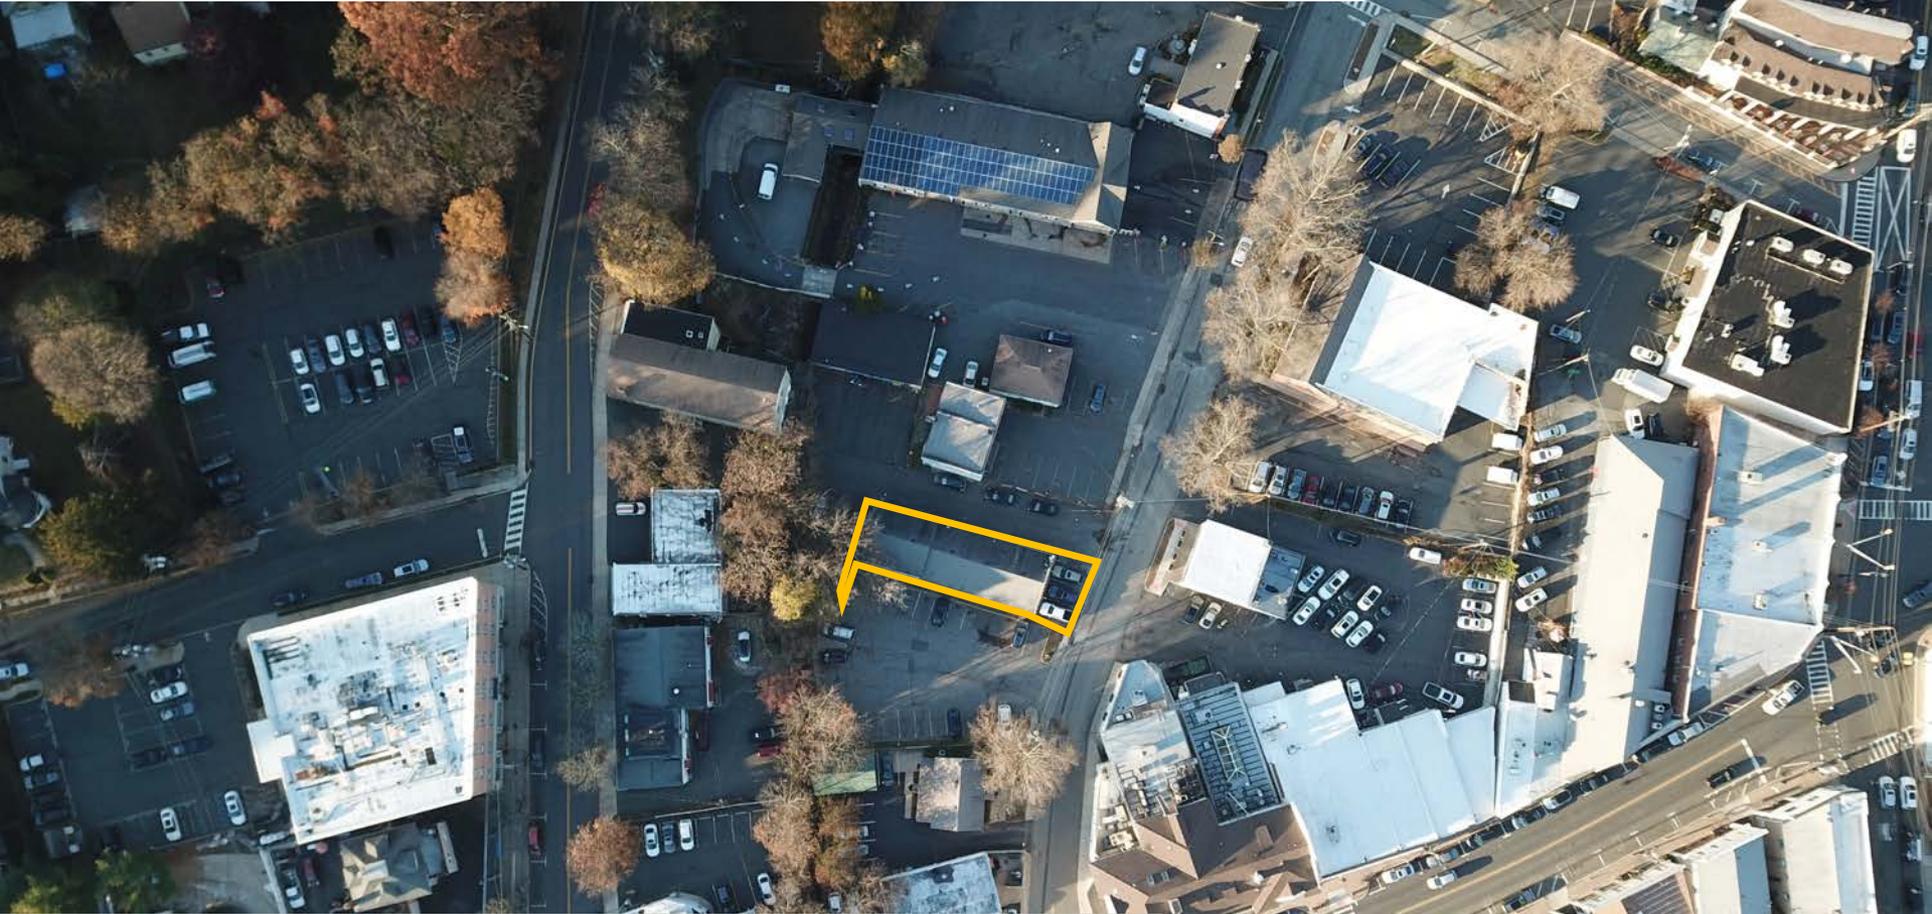
# Block 71, Lot 10: Criterion E

- Vehicular access to rear of site only possible by using adjacent properties
- No formal agreement identified
- Inter-dependence of parcels is a condition that would discourage the undertaking of improvements and investment, and reduce the viability of land that would otherwise be useful

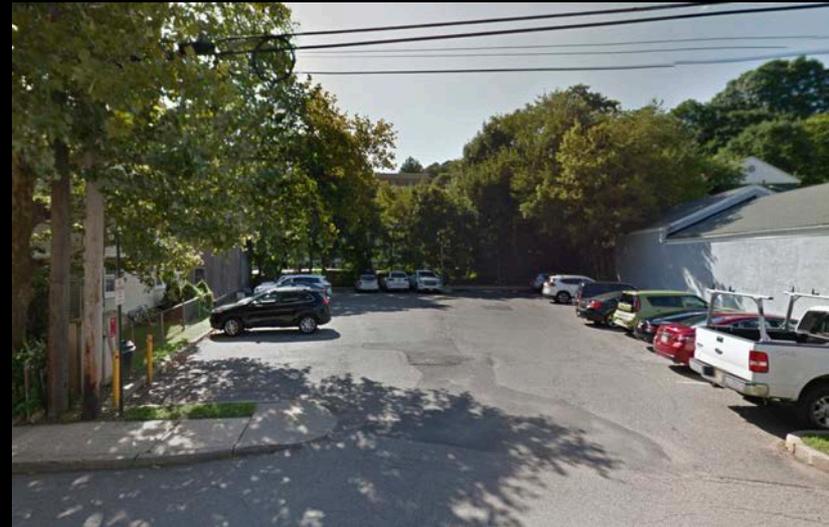
# Block 71, Lot 11: Criterion D

- **Obsolete land use detrimental to welfare**
  - Concerned Citizens supported finding that surface parking lots in downtown areas are evidence of obsolescence
  - Borough has undertaken effort to move away from auto-oriented uses and surface parking lots of “yesterday” in the downtown as reflected in 2004 Master Plan
  - Surface parking lots detract from pedestrian environment and discourage walkability, exhibit excessive lot coverage ratios that exacerbate flooding, and do not generate significant tax revenue
    - Improvement value of Block 71, Lot 11 per acre is \$0
    - Borough wide average is \$174,133

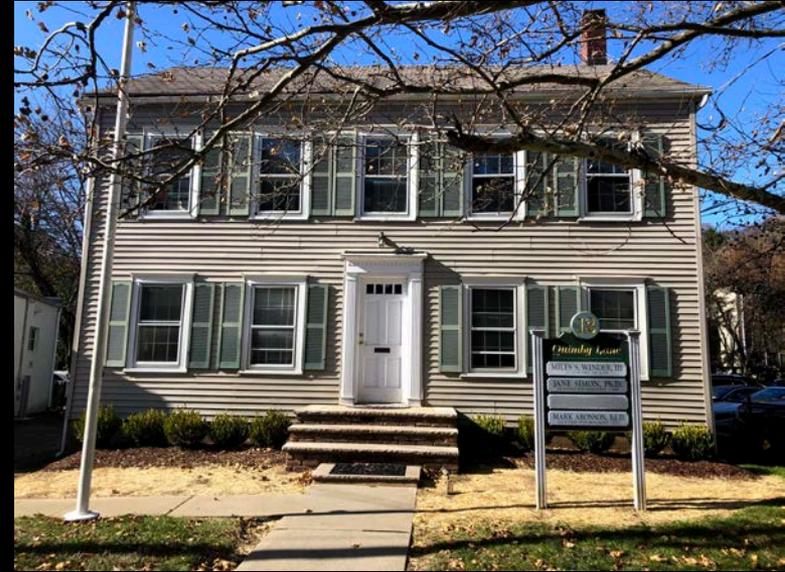
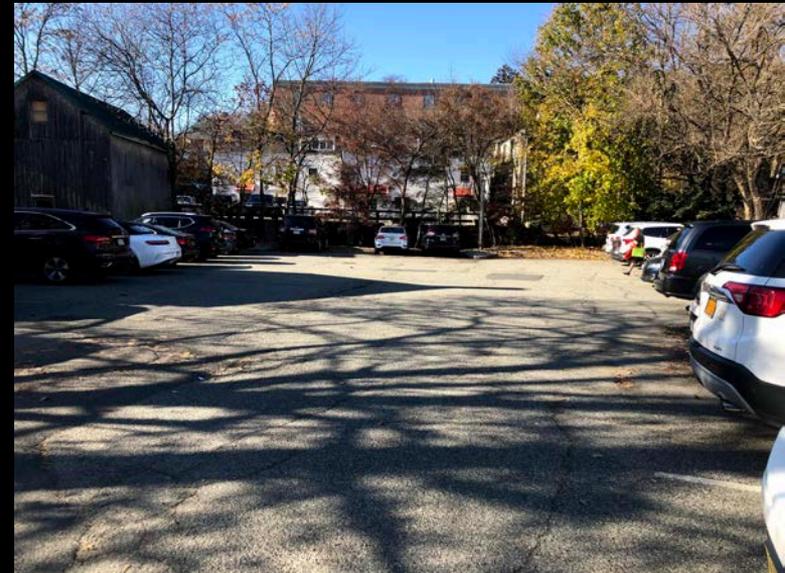
# Block 71, Lot 12: Criterion D

- **Faulty arrangement and obsolete layout detrimental to safety and welfare**
  - Development within the Regulatory Floodway without accommodations to mitigate on or off-site impacts of flooding creates a condition detrimental to safety of users of the building and to the welfare of the community

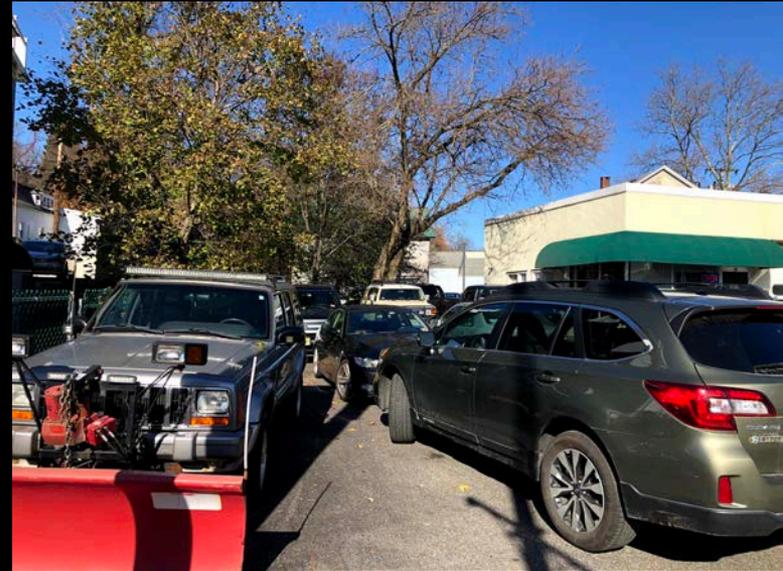
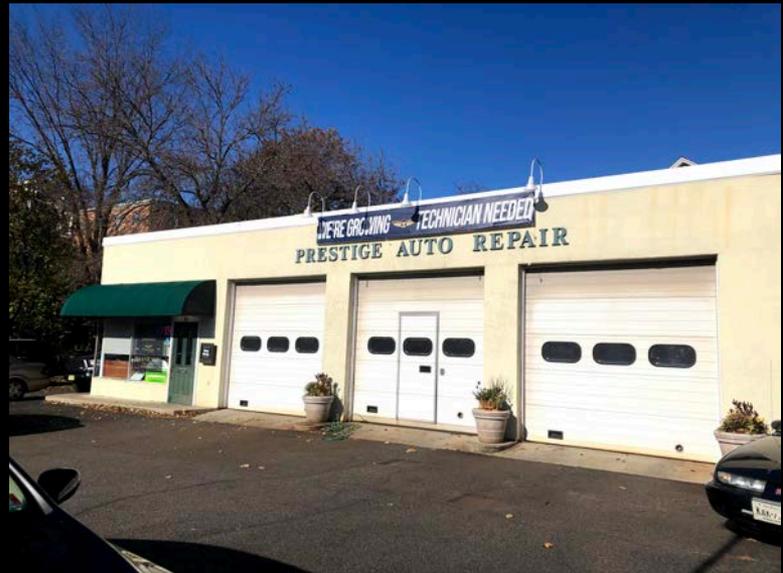
# Block 71, Lot 13: Criterion D

- Faulty arrangement, obsolete layout and use, and excessive land coverage detrimental to health, safety, and welfare
  - Excessive land coverage within the Floodway reflective of a faulty arrangement detrimental to safety
  - Lack of features to mitigate Floodway conditions reflective of obsolescence
  - Haphazard front yard vehicle storage reflective of faulty arrangement
  - Front-yard parking reflective of an obsolete layout that detracts from pedestrian environment and economic vibrance
  - Obsolete land use no longer appropriate for a downtown setting (Concerned Citizens)

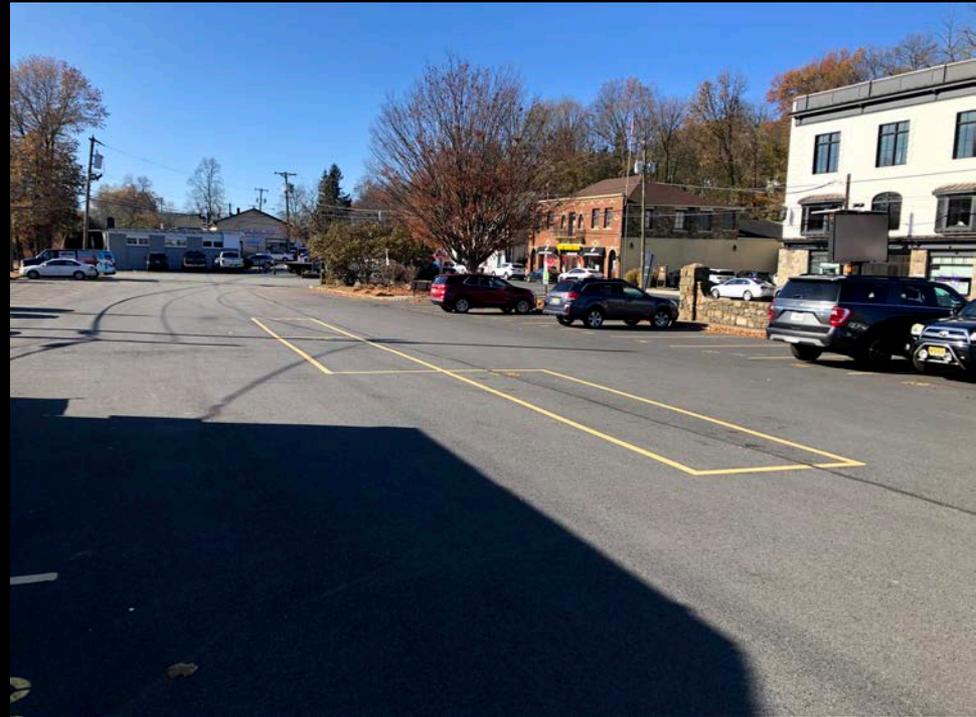
# Block 98, Lot 1: Criterion D

- **Obsolete land use detrimental to welfare**
  - Concerned Citizens supported finding that surface parking lots in downtown areas are evidence of obsolescence
  - Borough has undertaken effort to move away from auto-oriented uses and surface parking lots of “yesterday” in the downtown as reflected in 2004 Master Plan
  - Surface parking lots detract from pedestrian environment and discourage walkability, exhibit excessive lot coverage ratios that exacerbate flooding, and do not generate significant tax revenue
    - Improvement value of Block 98, Lot 1 per acre is \$0
    - Borough wide average is \$174,133

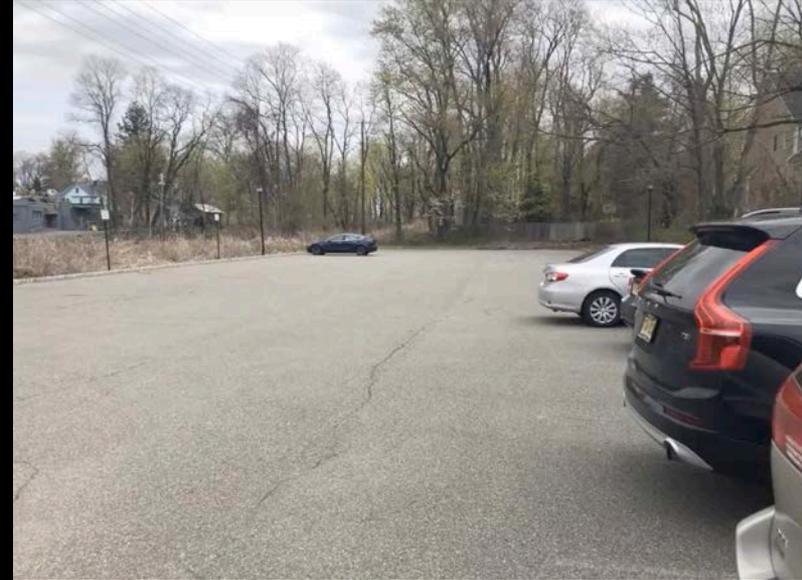
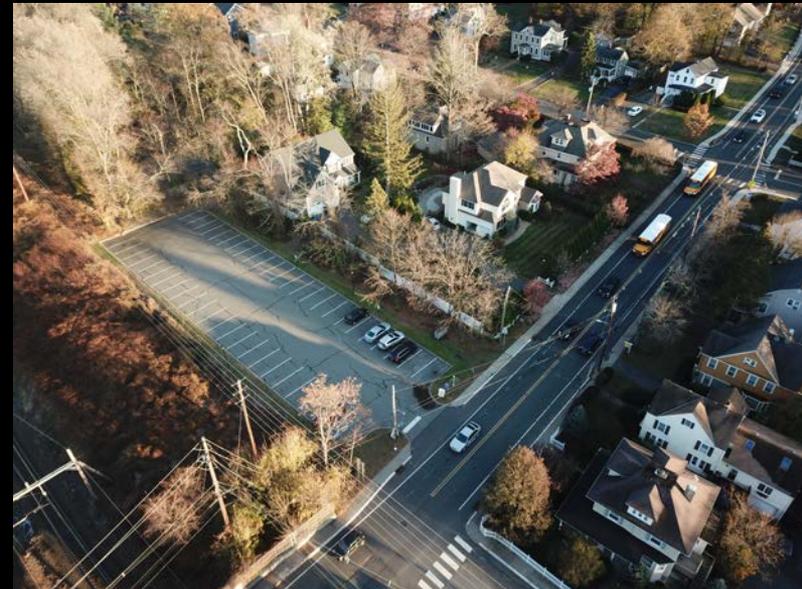
# Block 124, Lot 1: Criterion D

- **Obsolete land use detrimental to welfare**
  - Concerned Citizens supported finding that surface parking lots in downtown areas are evidence of obsolescence
  - Borough has undertaken effort to move away from auto-oriented uses and surface parking lots of “yesterday” in the downtown as reflected in 2004 Master Plan
  - Surface parking lots detract from pedestrian environment and discourage walkability, exhibit excessive lot coverage ratios that exacerbate flooding, and do not generate significant tax revenue
    - Improvement value of Block 124, Lot 1 per acre is \$0
    - Borough wide average is \$174,133

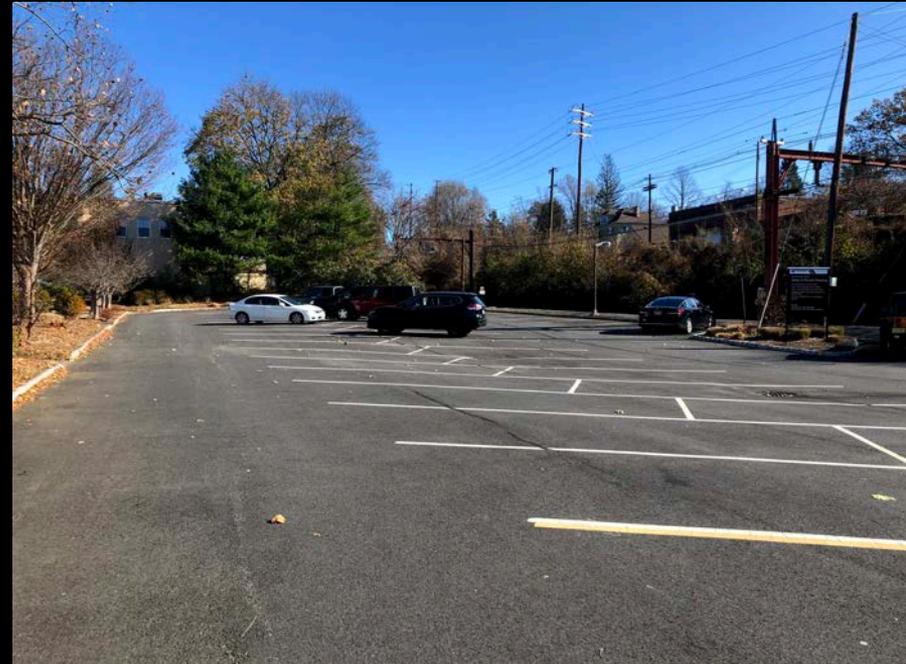
# Block 144, Lot 1: Criterion D

- **Obsolete land use detrimental to welfare**
  - Concerned Citizens supported finding that surface parking lots in downtown areas are evidence of obsolescence
  - Borough has undertaken effort to move away from auto-oriented uses and surface parking lots of “yesterday” in the downtown as reflected in 2004 Master Plan
  - Surface parking lots detract from pedestrian environment and discourage walkability, exhibit excessive lot coverage ratios that exacerbate flooding, and do not generate significant tax revenue
    - Improvement value of Block 144, Lot 1 per acre is \$37,769
    - Borough wide average is \$174,133

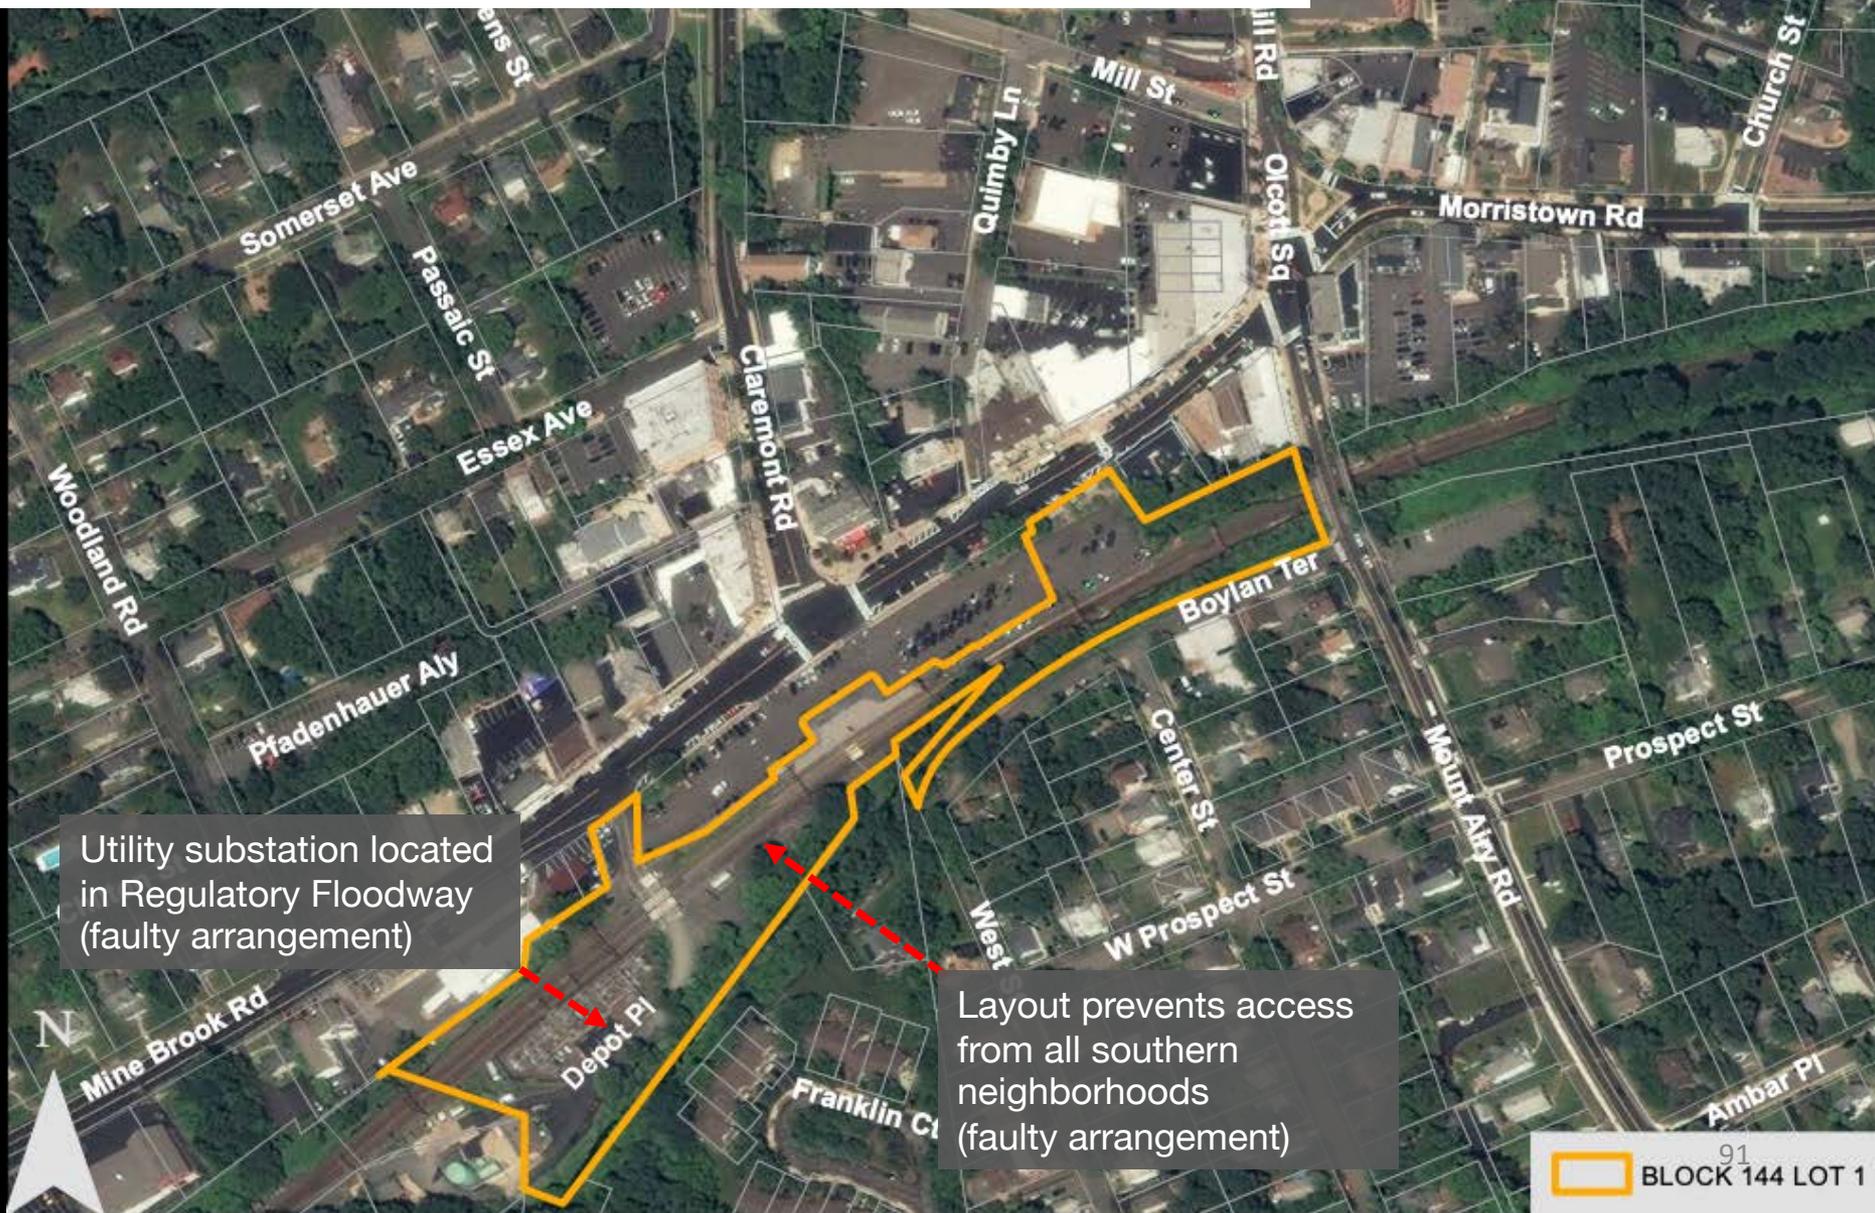
# Block 144, Lot 1: Criterion D

Utility substation located in Regulatory Floodway (faulty arrangement)

Layout prevents access from all southern neighborhoods (faulty arrangement)
